## **SERVICE BULLETIN 02-916**

- TO:** ALL OWNERS, OPERATORS AND MAINTENANCE PERSONNEL OF CESSNA T206H/206H/TU206G/U206G AIRCRAFT WITH THE SOLOY WING CAMERA MOUNT INSTALLED IN ACCORDANCE WITH SOLOY STC SA02478AT

- SUBJECT:** Wing crack inspection and doubler installation
- EFFECTIVITY:** All Cessna 206H, T206H, U206G, and TU206G airplanes that have wing-mounted camera system installed per Soloy, LLC STC SA02748AT, reissued June 28, 2010, or earlier revision.

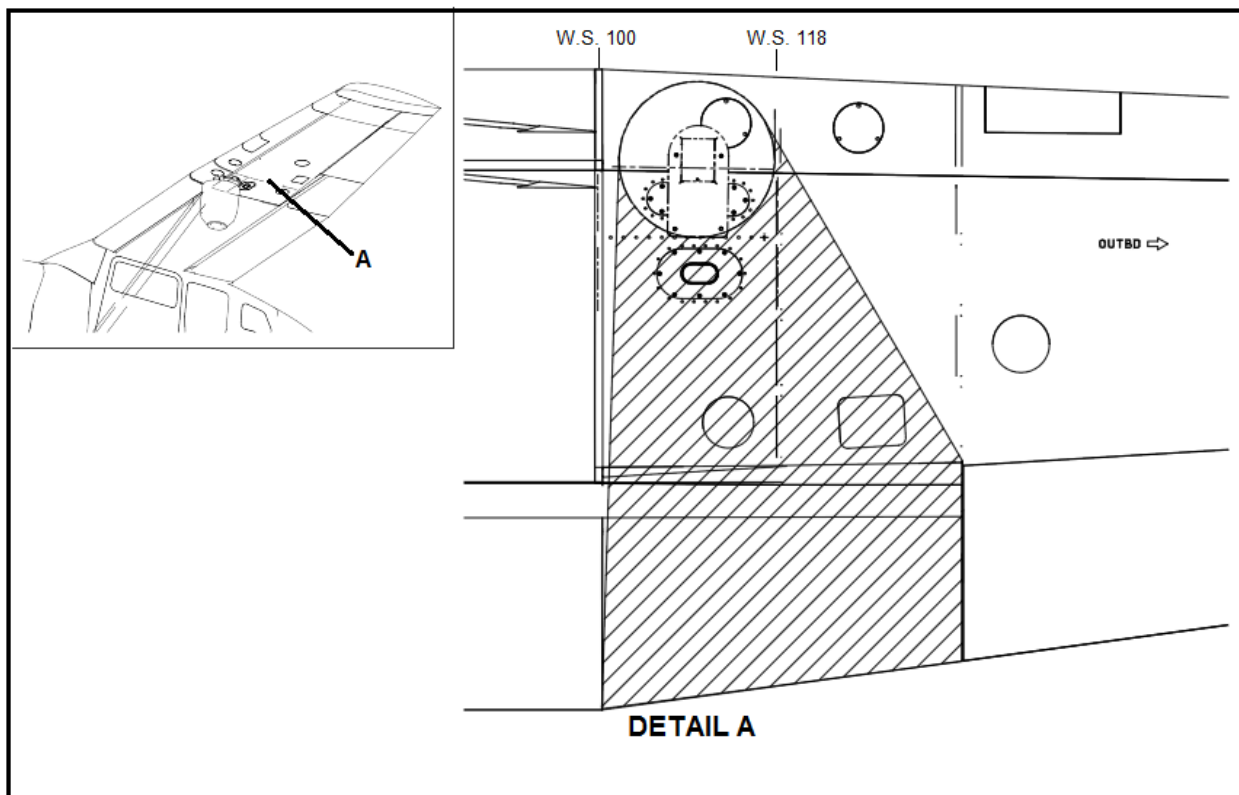
**FIGURE 1: Inspection Area**

4. Perform an internal detailed visual inspection of the interior wing structure in the area aft of the sensor mount for cracks (see Figure 1, shaded area). Access to the internal wing structure is through the aft access.

5. Perform an external detailed visual inspection of the left flap for cracks in the area shown on Figure 1. Pay particular attention to the flap skin at the outboard flap track (See Figure 3). Perform an internal inspection of the flap structure through the access panels on the upper surface of the flap.

6. Perform an external detailed visual inspect of the outboard flap cove area and upper wing trailing edge skin for cracks in the area shown on Figure 1. Areas of particular concern are the opening at the outboard flap actuator, the upper skin above the flap cove (see Figure 4) and the attach brackets at the outboard flap track.

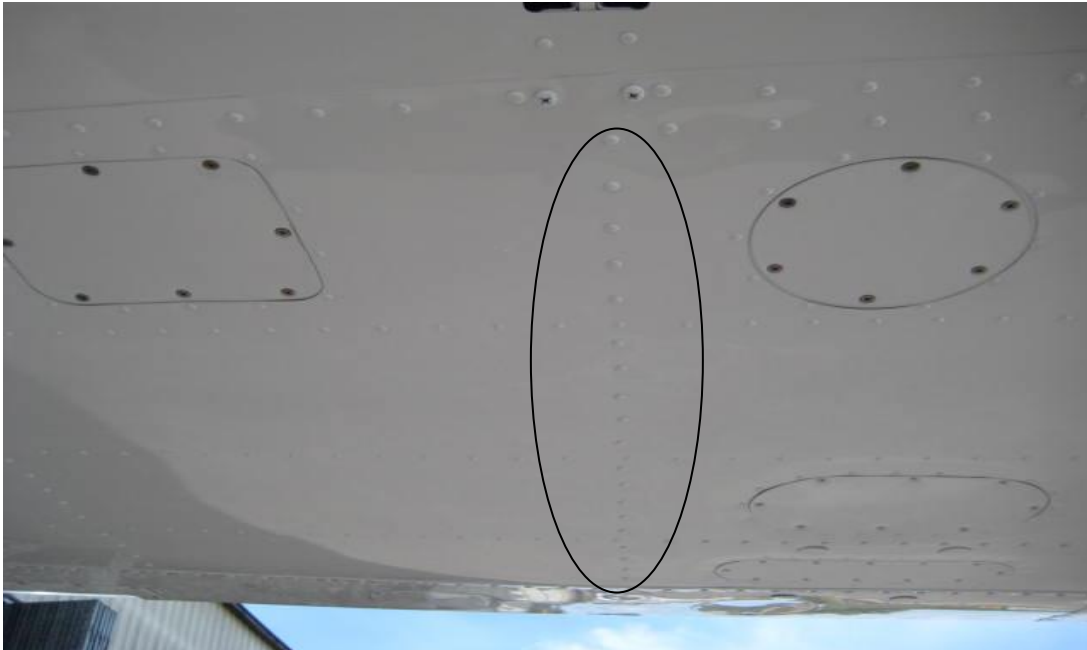
1. Lower the flaps to the full down position with the flap switch.
  - a. Ensure that the master switch is in the OFF position.
2. Remove the two aft wing access panels behind the sensor mount ( designated 510AB and 510DB on H model aircraft).
3. Perform an external detailed visual inspection of the left lower wing skin in the area aft of the sensor mount for cracks (see Figure 1, shaded area). Pay particular attention to the wing skin rivets on the rib line (W.S. 118.0) forward of the outboard flap track (see Figure 2).

**Figure 2:** Left Lower Wing Skin Area of Particular Interest, Rib W.S. 118.0

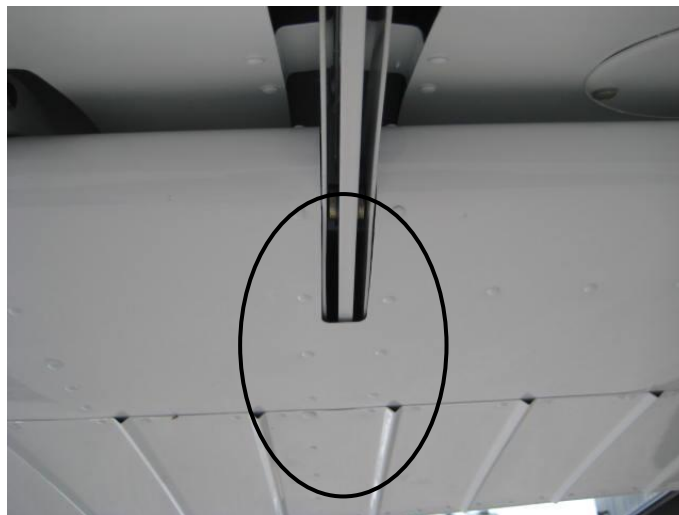
**Figure 3:** Outboard Flap Track Area of Particular Interest, Rib W.S. 118.0

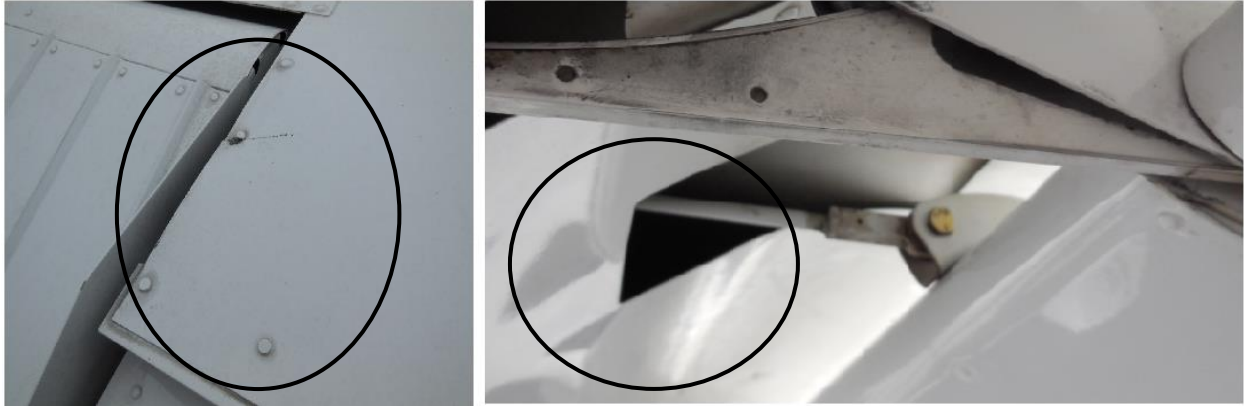
**Figure 4:** Upper and Lower Flap Cove Areas of Particular Interest
