SERVICE BULLETIN 01-916

- SUBJECT:** Inspection of wing skin
- EFFECTIVITY:** All Cessna 206 aircraft equipped with Soloy P/N 916-1000 camera mount.
- COMPLIANCE:** Inspect left wing lower skin and flap for cracks upon receipt of this bulletin.

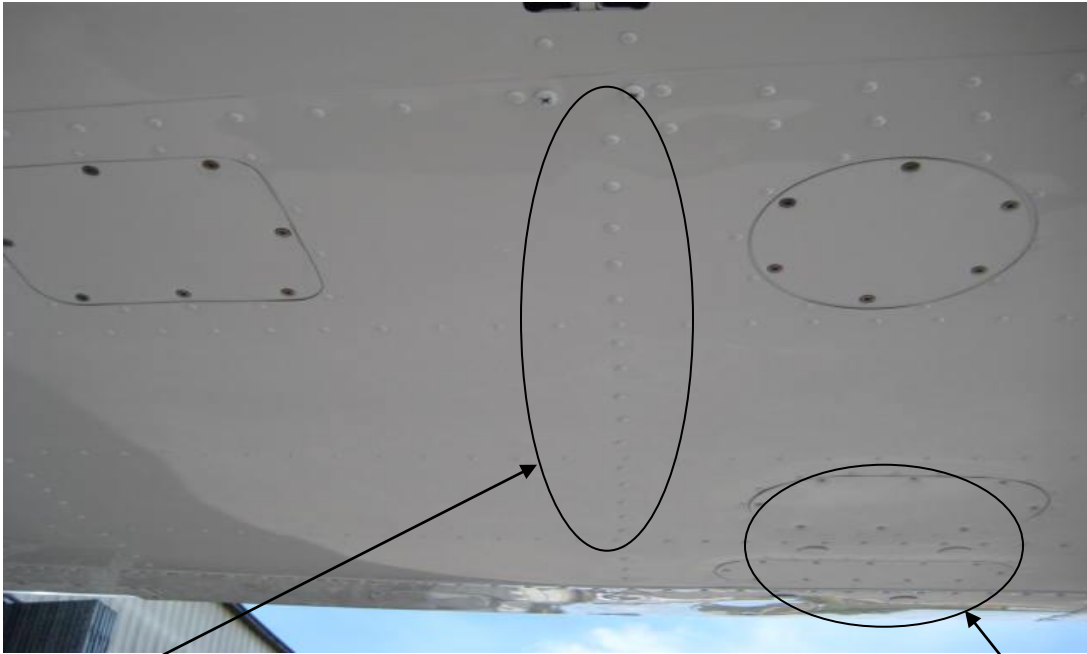
- DESCRIPTION:** It has been reported to Soloy that an aircraft with Soloy camera mount 916-1000 and installed turret has developed several skin cracks on the bottom of the left wing and also a crack on the left lower flap. These cracks do not involve the camera mount modification to the wing but due to the proximity of the cracks Soloy has issued this bulletin. The area in question is the rib and stringer intersect forward of the flap outboard attach point. A crack has also been noted on the flap in the area of the out board attach point. Inspect wing and flap in accordance with instructions below. Visual inspection should be performed at preflight and or post flight when turret is installed.

Area of concern

Camera mount location

1. Visually inspect the left lower wing skin in the area of the camera mount for cracks. Also inspect the wing skin on the rib line forward of the outboard flap attach point. If a crack is noted, inspect wing structure in immediate area for possible hidden damage.
2. Visually inspect the left flap for cracks in the area of the outboard attach point.
3. Inspect outboard flap cove area and upper wing trailing edge skin for cracks.
4. If a crack is noted, contact Soloy Aviation Solutions.

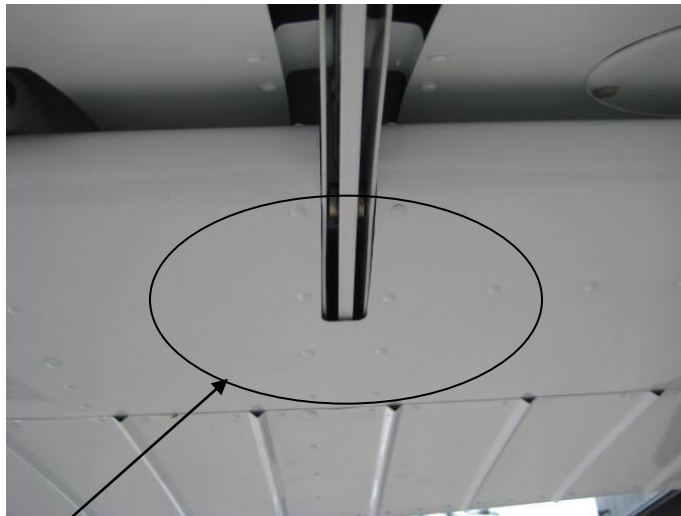
Area of concern
